Exploring the Lighthouse of *El Morro* in San Felipe: Professional Practice and Academic Collaboration for the Conservation of Immovable Cultural Heritage in Old San Juan, Puerto Rico

DOI: 10.30763/Intervencion.297.v1n29.76.2024 · YEAR 15, ISSUE NO. 29: 211-233

Sarahí Soriano Orozco

Rodrigo Sáinz Lara

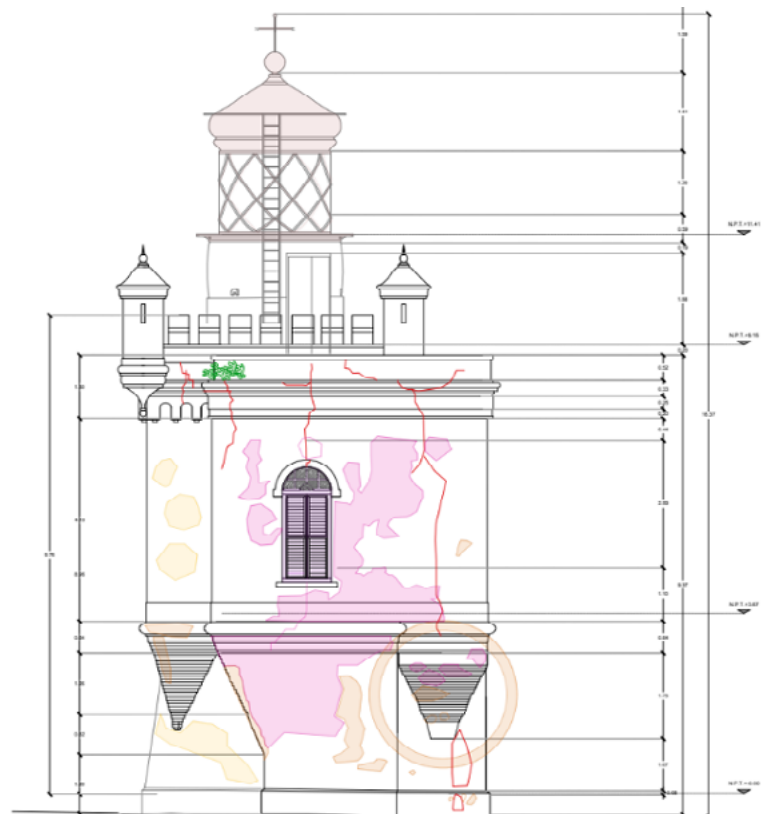
F4-FACHADA ESTE
FARO EL MORRO ESC. 1:50

Damage to the Lighthouse is predominantly related to lack of maintenance, visible in the building's finishes, both interior and exterior. These have been caused by water infiltrations in the cover and structural problems resulting from the geometry of the building, which has led to cracks and fissures of cantilever elements. Furthermore, factors of the coastal environment, which promote corrosion of metal objects, the emergence of efflorescence on walls and weathering of masonry elements. Additionally, through *in situ* observation we identified that the materials used during the different periods did not react to the environment in the same way, determining that (Figures 6 and 7):

FIGURE 6.
Schematic of the damage survey of *El Morro* Lighthouse in San Felipe (East elevation) (Drawing: Sarahí Soriano and Rodrigo Sáinz, 2019).
