Exploring the Lighthouse of *El Morro* in San Felipe: Professional Practice and Academic Collaboration for the Conservation of Immovable Cultural Heritage in Old San Juan, Puerto Rico

DOI: 10.30763/Intervencion.297.v1n29.76.2024 · YEAR 15, ISSUE NO. 29: 211-233

Sarahí Soriano Orozco

Rodrigo Sáinz Lara

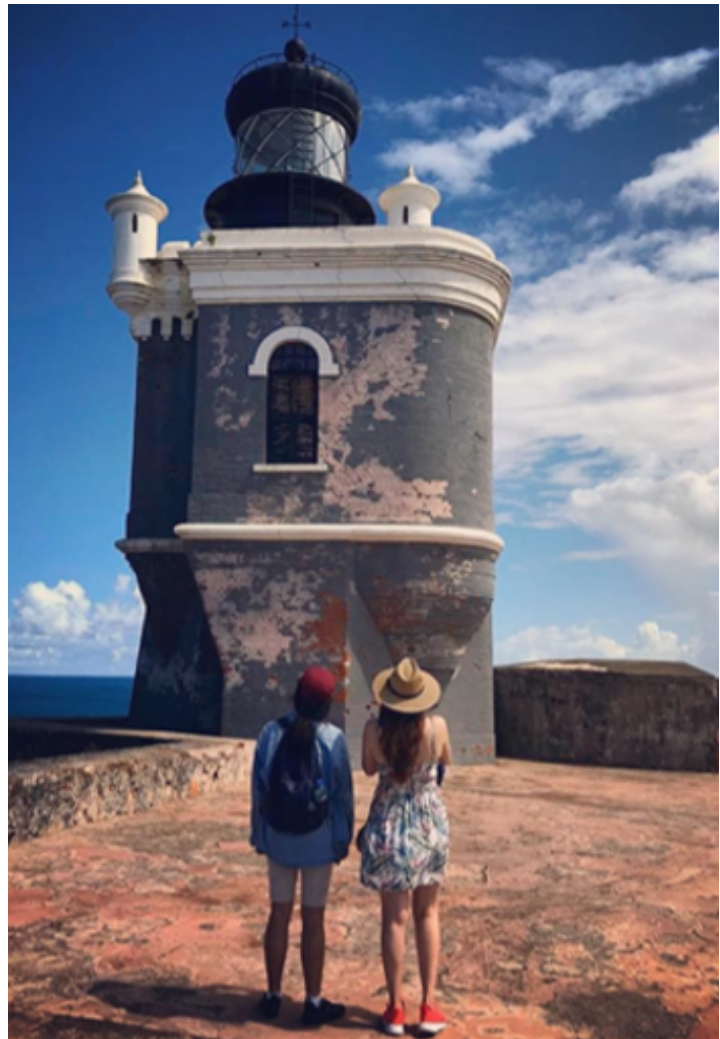
FIGURE 8.
Photograph of *El Morro* Lighthouse
in San Felipe
(Photograph: Sarahí
Soriano and Rodrigo
Sáinz, 2019).

The Lighthouse in the *El Morro* Castle in San Felipe, though relatively young, has elements from different periods which reflect the political and cultural history of Puerto Rico (Figure 8). Its evolution fits the concept of first and second history following the context of Brandi's

Theory of Restoration (1995 [1963], p. 17), in which each development phase has its own importance. The proposed intervention was based on the notion that the building must preserve its original purpose, as an element of coastal signaling,¹⁴ as well as its stability; and that access to it must be permitted to enhance its historical value. It states that modifying its current location would be contradictory to the conservation of its values. *The Venice Charter* (ICOMOS, 1964, p. 2) stresses the importance that a monument be linked to its history and location, and that its transfer should only be considered under extraordinary circumstances. This intervention seeks to recover the building's stability without altering its aesthetic appearance nor its historical and cultural context. Its focus is conserving the essence of the monument, avoiding unnecessary changes.
